On the Embrittlement of Zircaloy-4 Under RIA-Relevant Conditions*

REFERENCE: Daum, R. S., Majumdar, S., Bates, D. W., Motta, A. T., Koss, D. A., and Billone, M. C., "On the Embrittlement of Zircaloy-4 Under RIA-Relevant Conditions," *Zirconium in the Nuclear Industry: Thirteenth International Symposium, ASTM STP 1423*, G. D. Moan and P. Rudling, Eds., ASTM International, West Conshohocken, PA, 2002, pp. 702–719.

KEYWORDS: mechanical properties, ring stretch specimens, Zircaloy-4 cladding, hydrides, hydride rim, stress-state, fracture strain

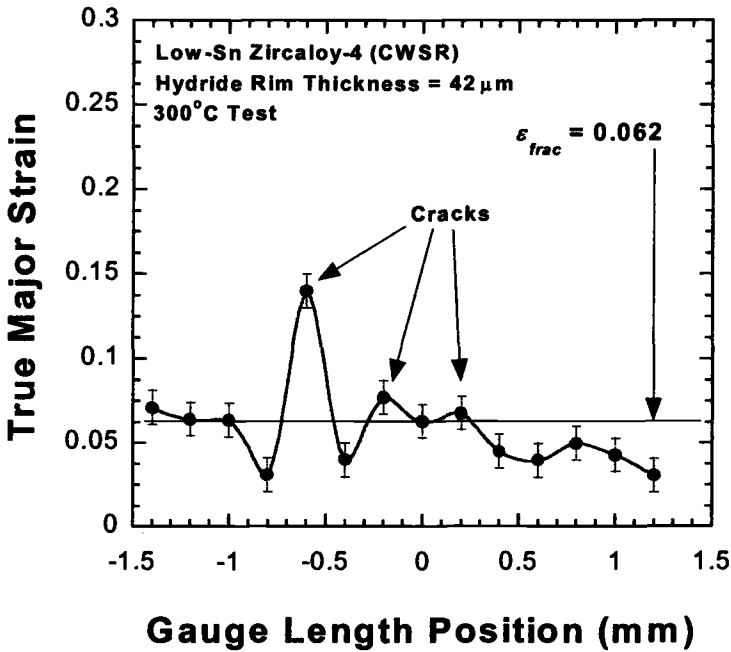
FIG. 4—(a) Schematic of Mode I cracks with respect to microhardness indentation array and corresponding schematic of strain distribution of Indent Row #2 (dimensions in millimeters and not-to-scale) and (b) actual strain distribution of plane-strain ring-stretch specimen (N7R#1) with hydride layer thickness of 42 μm tested at 300 $^{\circ}\text{C}$.

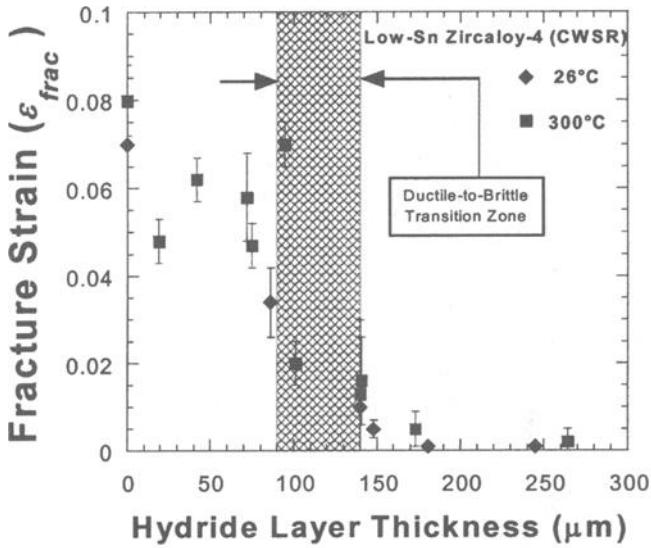
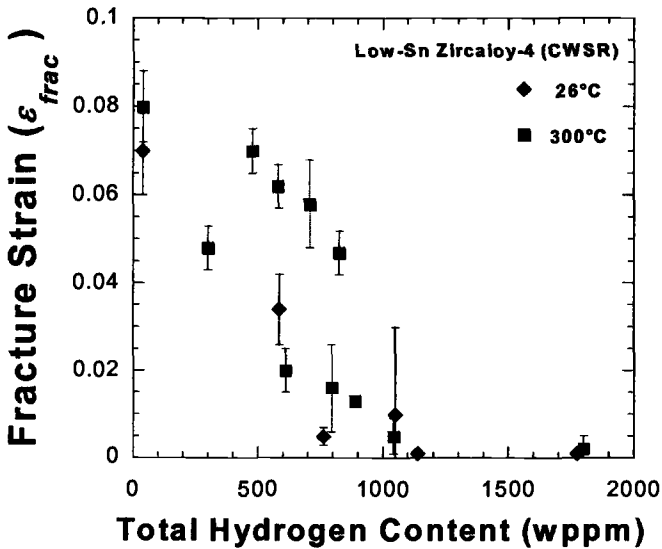
FIG. 7—Fracture strain (ϵ_{frac}) at room temperature and 300°C as a function of (a) hydride layer thickness and (b) total hydrogen content.

Figure 7 shows the dependence of the fracture strains on thickness of the hydride rims and total hydrogen content in Zircaloy cladding tubes deformed to failure at near plane-strain tension at room temperature and 300°C (these results are also shown in numerical form in the Appendix). It is important to recognize that these ring-stretch tests impose a biaxial stress state that results in near plane-strain deformation path with the major principal strain component being the hoop strain. The most important trend in Fig. 7 is the obvious dependence of cladding ductility on hydride-rim thickness (see Fig. 7a). At both room temperature and 300°C, there appears to be a gradual ductile-to-brittle transition with increasing hydride layer thickness. Specifically, cladding with hydride rims of thicknesses ≥ 140 μm show little or no plastic deformation to failure. In view of the fact that the experimental accuracy of our measurements of local strain is ± 0.01 , we concluded that these cladding tubes are essentially brittle. At the 100- μm hydride thickness level, there may be a small level of plastic deformation to the cladding prior to failure. However, cladding samples with hydride-rim thicknesses < 90 μm are distinctly ductile with hoop failure strains of roughly 0.04 or greater. We have not collected sufficient data to detect the expected influence of temperature on the ductile-to-brittle transition.

As an alternative approach to examining the influence of hydrogen on failure of the Zircaloy, Fig. 7b presents the dependence of fracture on total hydrogen content. The brittle cladding with a thick hydride rim had total hydrogen contents ≥ 700 wppm. Although most of the ductile specimens had hydrogen contents in the 300 to 600 wppm range, ductility was also observed in specimens with thin hydride layers in excess of 700 wppm hydrogen. Therefore, comparing Figs. 7a and 7b, it is clear that the ductile-to-brittle transition as a function of hydride rim thickness is sharper or more definable than the similar transition as a function of total hydrogen content. For example, in Fig. 7b, several results are in the 500 to 1000 wppm range with similar hydrogen concentrations but widely varying values of ductility. This is because these samples have different hydride layer thicknesses, and, thus, thickness is the predominant factor in causing failure.

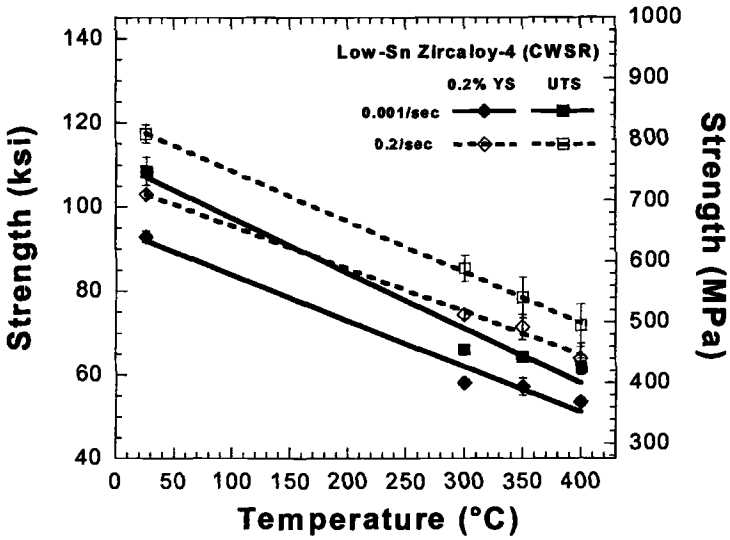
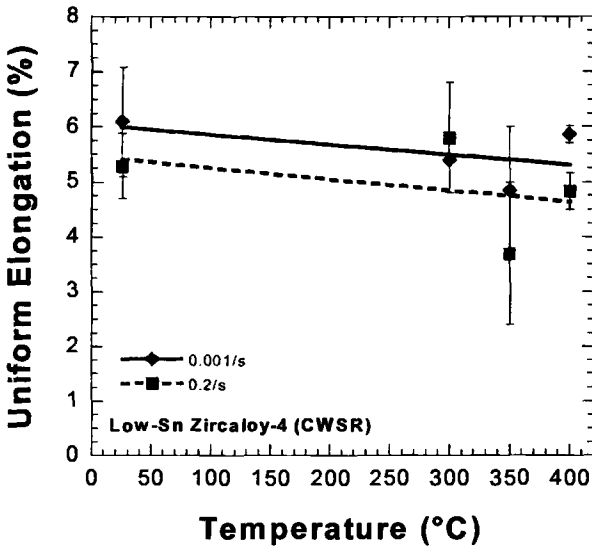
FIG. 8—(a) Yield and ultimate tensile strengths and (b) uniform elongation for non-irradiated cladding as a function of temperature and strain rate.

Uniaxial ring-stretch specimens were machined from as-fabricated cladding (no hydrogen) and tested under thermal and mechanical loadings relevant to the RIA transient in order to obtain baseline stress-strain data for comparison to irradiated cladding. Figure 8 shows results of yield strength (YS) and ultimate tensile strength (UTS) and uniform elongation as a function of temperature and strain rate for the Zircaloy deformed in the hoop direction of the cladding tube.

As shown in Fig. 8a, the Zircaloy exhibits strain-rate hardening and strain-rate sensitivity (m), such that $m = d(\ln \sigma)/d(\ln \dot{\epsilon})$ and is found to depend on temperature, where σ is the true stress, and $\dot{\epsilon}$ is the strain rate. This study and previous studies have reported a strain-hardening exponent (n) value of 0.06 from compression and tensile tests of specimens oriented for hoop deformation, where $n = d(\ln \sigma)/d(\ln \epsilon)$ and ϵ is the true plastic strain [13,14]. For deformation in the axial direction of Zircaloy-4 in the CWSR and unirradiated condition, limited room-temperature testing has found $n = 0.07$ [13,14]. Figure 8b shows uniform elongation to be relatively insensitive to temperature and to have a nominal value of 0.06 at low strain rates, which is consistent with the measured n -values. There appears to be a small decrease in uniform elongation at the higher strain rate for all testing temperatures.
