# THE INFLUENCE OF A HYDRIDED LAYER ON THE FRACTURE OF ZIRCALOY-4 CLADDING TUBES

Robert S. Daum  
Argonne National Laboratory, Argonne, IL 60439

Douglas W. Bates<sup>1</sup>, Donald A. Koss and Arthur T. Motta  
The Pennsylvania State University, University Park, PA 16802  
(<sup>1</sup>Currently with United States Navy)

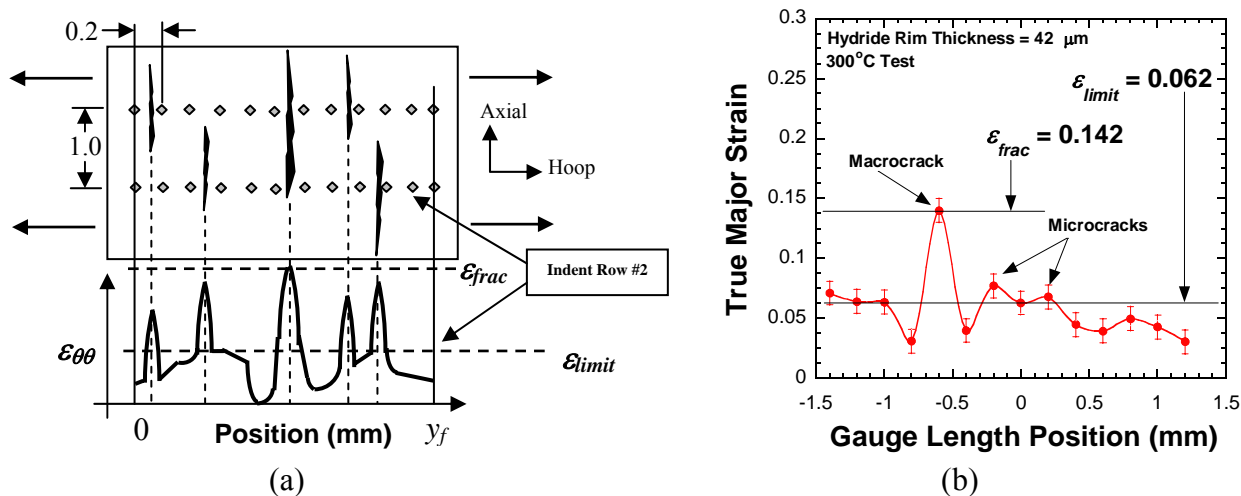
Figure 5 – (a) Schematic of the influence of microcracks on the strain distribution along Indent Row #2 (dimensions in millimeters and not-to-scale) and (b) the measured strain distribution at cladding fracture for a plane-strain ring-stretch specimen with hydride layer thickness of  $42 \mu\text{m}$  tested at  $300^\circ\text{C}$ .

Failure of the hydrided Zircaloy cladding was determined on the basis of strain distributions of failed specimens, as shown in Fig. 5a (where  $\varepsilon_{\theta\theta}$  is the true major strain and  $y_f$  is the total gauge length in the hoop direction). It should be noted that our strain values are based on elements initially 0.2 mm long. Thus, Fig. 5b indicates finite strain levels adjacent to a crack over the 0.2 mm length, even though we expect near zero strains immediately adjacent to the crack.

those crack opening displacements associated with arrested microcracks and the macrocrack. Figure 5b indicates  $\epsilon_{limit} \cong 0.06$  as the level of strain present along the cladding tube at locations between cracks. The  $\epsilon_{limit}$  value may be viewed as a lower limit of the cladding failure strain for unirradiated, hydrided cladding.

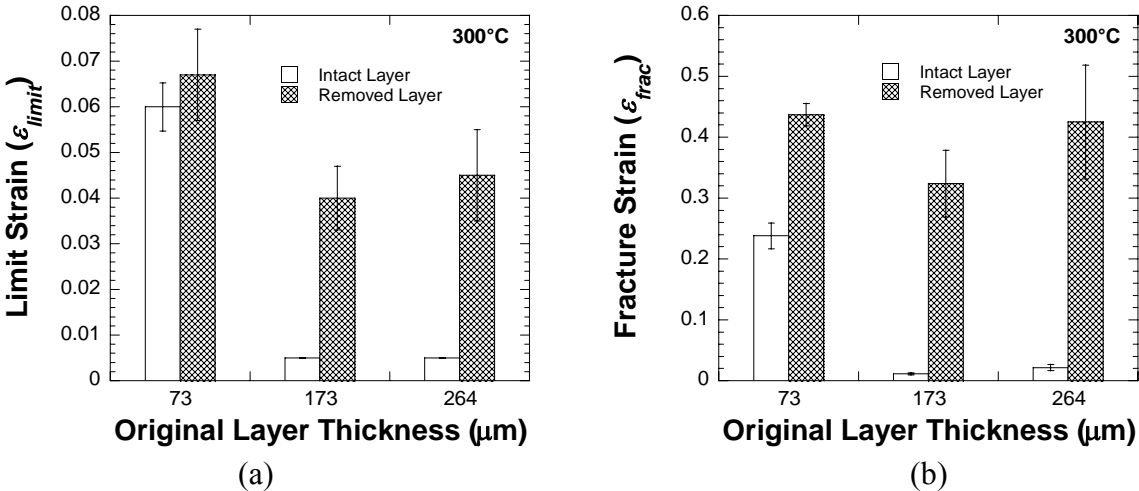
Figure 7: (a) Limit strain ( $\epsilon_{limit}$ ) and (b) fracture strain ( $\epsilon_{frac}$ ) at 300°C as a function of original hydride layer thickness for cladding with intact and removed layer.

Finally, to confirm that the ductility losses presented above in Fig. 6 are indeed caused by the presence of the hydride rim, we present Fig. 7. This figure is based on the behavior of *sibling* specimens with the hydride rim intact and mechanically removed. These results indicate that the previously brittle cladding is ductile once the hydride layer is removed. Removing the hydride rim restores the  $\epsilon_{limit}$  and  $\epsilon_{frac}$  values to levels close to those determined for unhydrided cladding.
